ASOS MODIFICATION NOTE 31 (for Electronics Technicians)

SUBJECT : ACU Memory Firmware Version 2.3 and ACU CPU Firmware 1.81

PURPOSE : To add Freezing Rain, preliminary Meteorological Aviation Report (METAR) and ASOS Controller Equipment (ACE) enhancements.

EQUIPMENT : ASOS Acquisition Control Unit (AACU)
AFFECTED

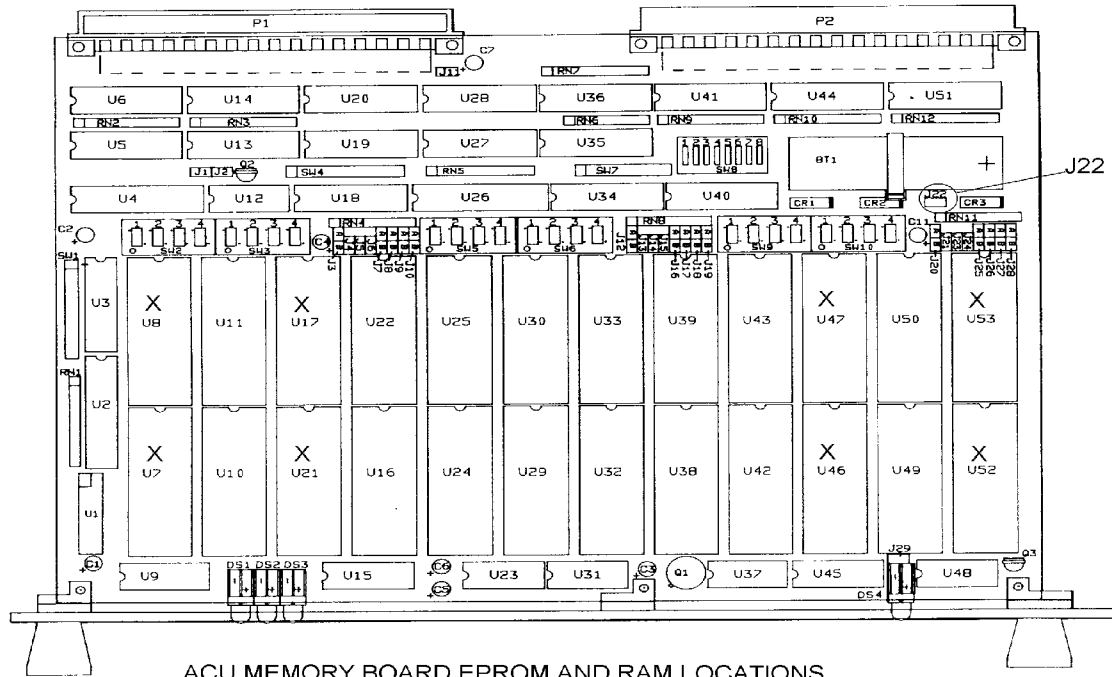
FIGURE 1

ACU MEMORY BOARD EPROM AND RAM LOCATIONS

EPROM
U7
U8
U17
U21

RAM
U46
U47
U52
U53

11. Using the IC insertion tool, remove the new EPROM ICs from protective packaging and insert them into the ACU memory board sockets in accordance with the following chart. Ensure that the EPROMs are installed with pin 1 (as identified by notch in top of IC) oriented toward board connector P1 and P2 as shown on Figure 1.

<u>IC socket</u>	<u>IC part number</u>
U8	62828-45002-1
U17	62828-45003-1
U7	62828-45004-1
U21	62828-45005-1

12. Using the IC insertion tool, remove the RAM ICs from protective packaging and insert them into the ACU memory board sockets U46, U47, U52 and U53. Ensure that the RAMs are installed with pin 1 (as identified by notch in top of IC) oriented toward board connector P1 and P2 as shown on Figure 1. U52 already has a clock chip installed. **DO NOT REMOVE THE CLOCK CHIP.** Install the RAM chip on top of the clock chip.

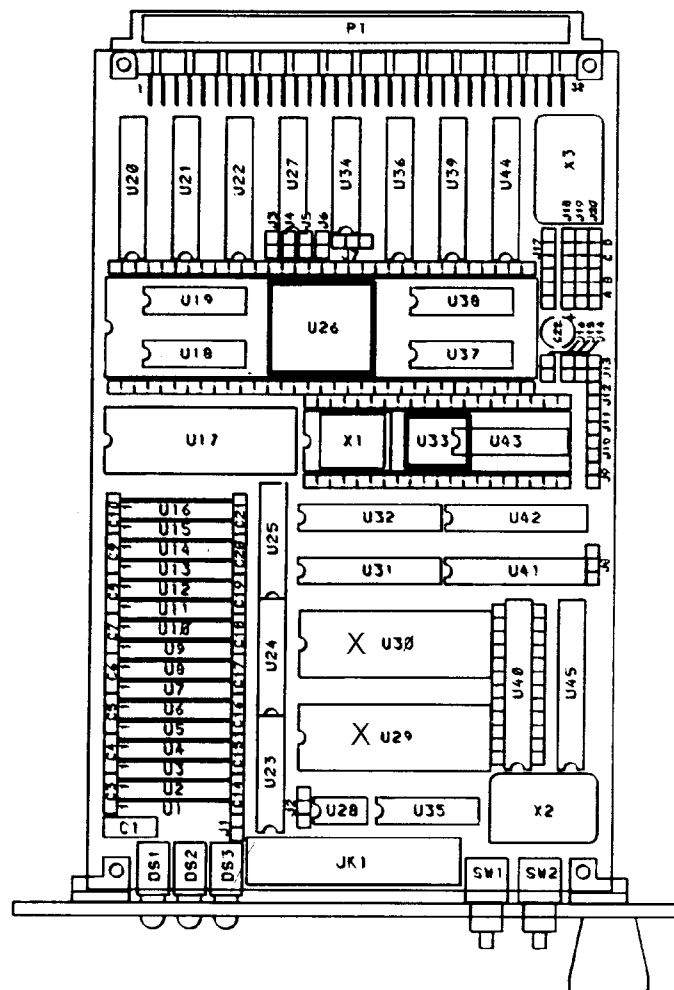
FIGURE 2

CPU BOARD

EPROM
U29
U30

17. Use a small flat blade screwdriver and tighten the captive screws located at top and bottom of boards and blank panels.
18. If required, remove the new EPROM ICs from the protective packaging. Use an IC insertion tool to insert the EPROMs into the ACU CPU board's sockets (1A2A1 and 1A2A2) in accordance with the following chart. Ensure that all the EPROMs are installed with pin 1 (as identified by notch in top of IC) oriented toward the top of the ACU CPU board as shown on Figure 2.

<u>IC socket</u>	<u>IC part number</u>
U29	62828-45000-1
U30	62828-45001-1
